Fish Bearing Stream Assessments

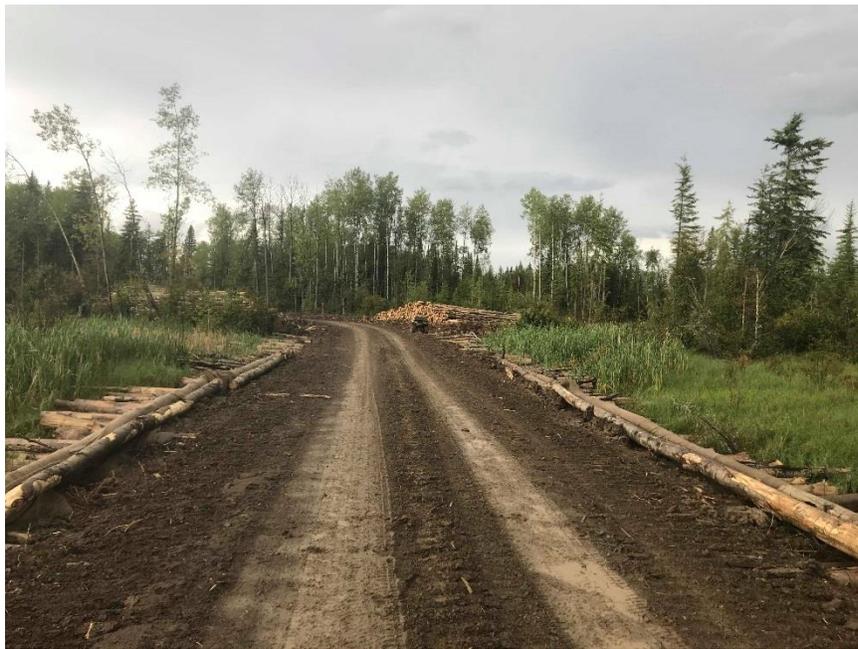
Figure 2. Temporary stream crossing in a cutblock. Modified logfill.

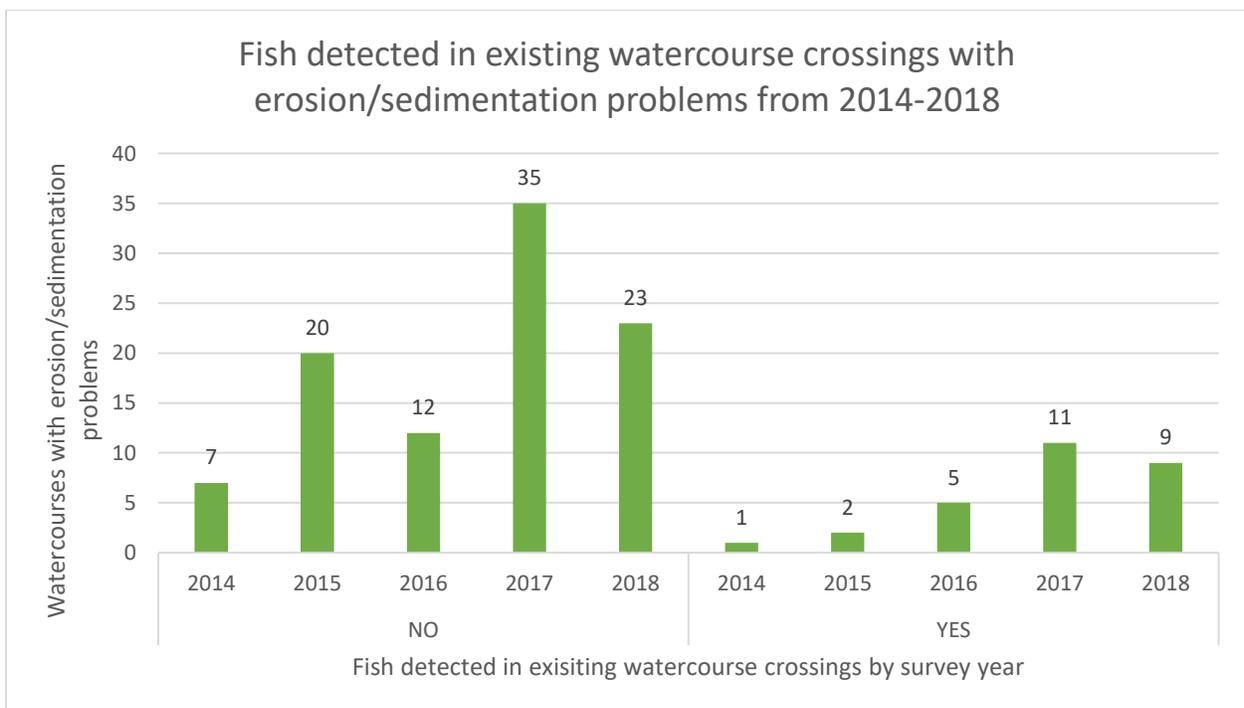
Figure 6. Fish detected in existing watercourse crossings with erosion/sedimentation problems surveyed (2014-2018)

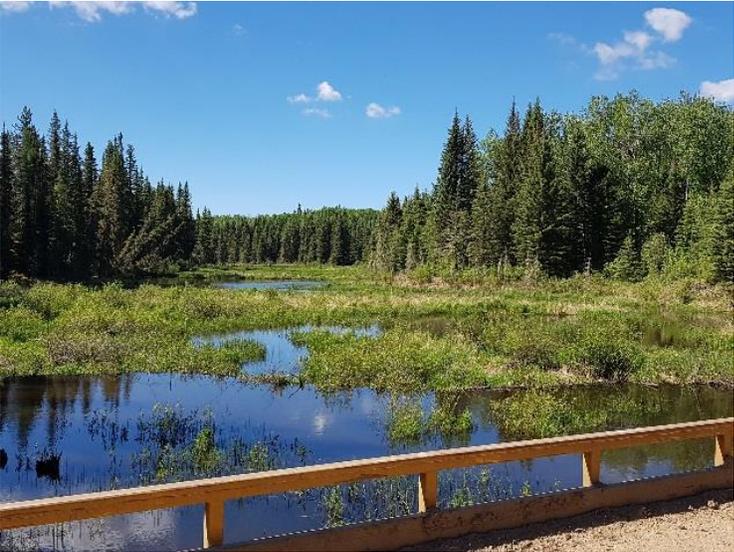
Figure 8. Existing watercourse crossing in the process of being surveyed

Each year, every existing permanent crossing is inspected and compared to the previous years of the crossings existence. An example of an existing watercourse crossing in the process of being monitored can be seen in Figure 8 with the surveyors being visible in Figure 9. This information can be used to inform best practices in the construction of watercourse crossings and aid in the protection of water and fish resources.

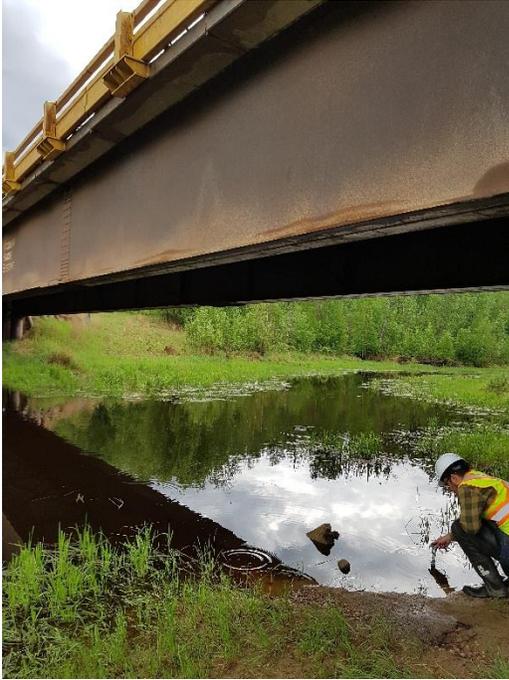
Figure 9. Existing permanent watercourse being surveyed
